# PROBLEMS WITH AXLE/DAMPER CONNECTORS

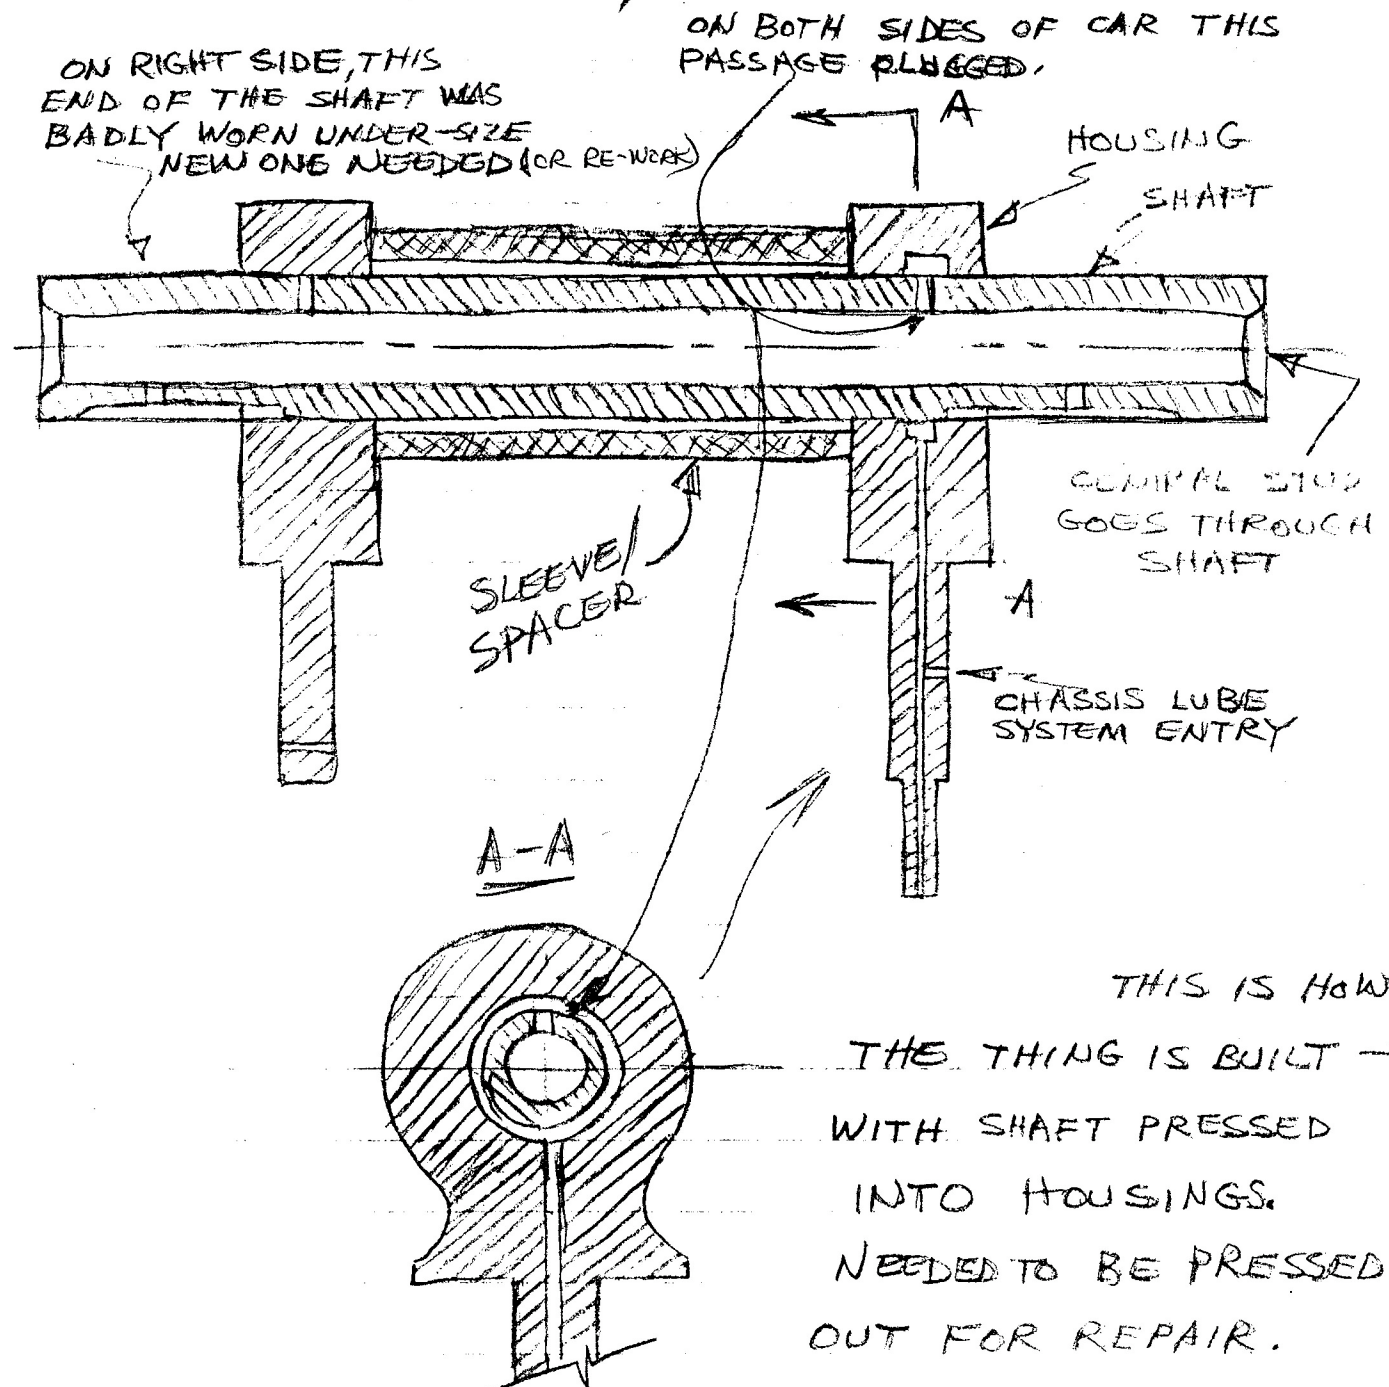
① RIGHT SIDE NEEDED NEW CENTRAL STUD;  
THEN NEEDED END CAP RE-TAPPED, AND STUD  
INSERTED, SWAGED, PEENED.

② RENOVATE PLUGGED/RUSTED PARTS, BOTH SIDES.
