# SERVICE INSTRUCTION LEAFLET

BENTLEY MOTORS (1931) LTD.

Subject : OVERHAUL OF STEERING PIVOT PINS  
BENTLEY 3½ & 4½ LITRE MODELS

Derby Bentley Society – technical paper compilation

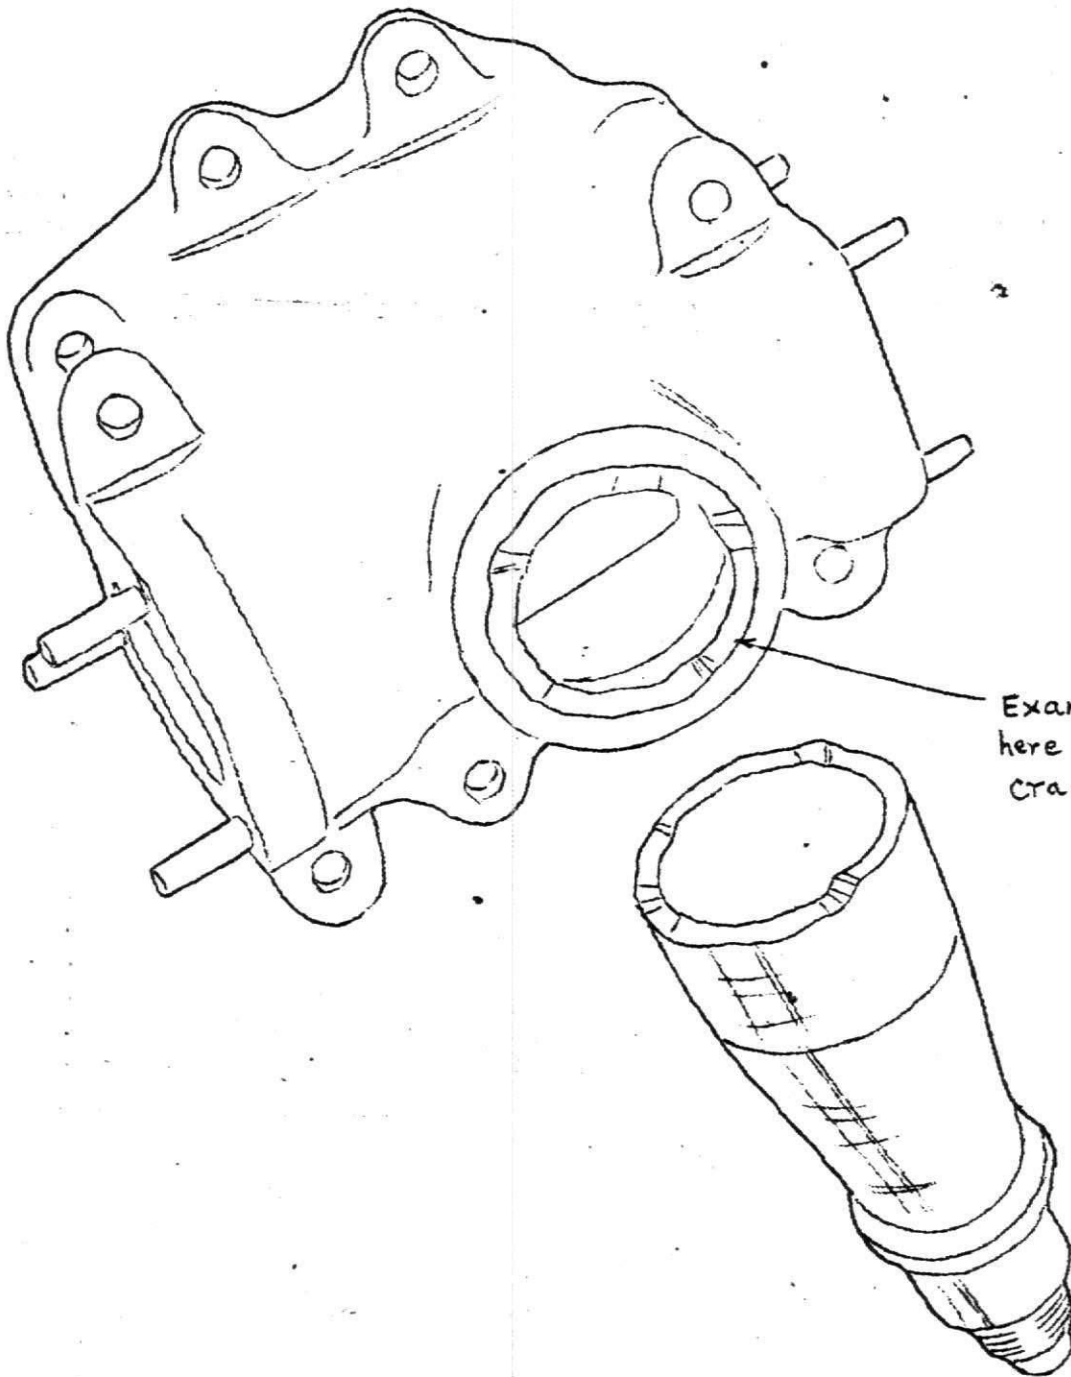
Hd 282

A case has occurred on an Experimental Bentley car, which has done a very large mileage under particularly abnormal and strenuous conditions, of a pivot failing, as shown on the attached Sketch.

Examine round  
here for sign of  
cracks.

We recommend that, as opportunities occur, cars which have done 30,000 miles and over should be examined at this point.

In view of this failure, all pivots fitted to new cars are being strengthened up from the present date onwards.

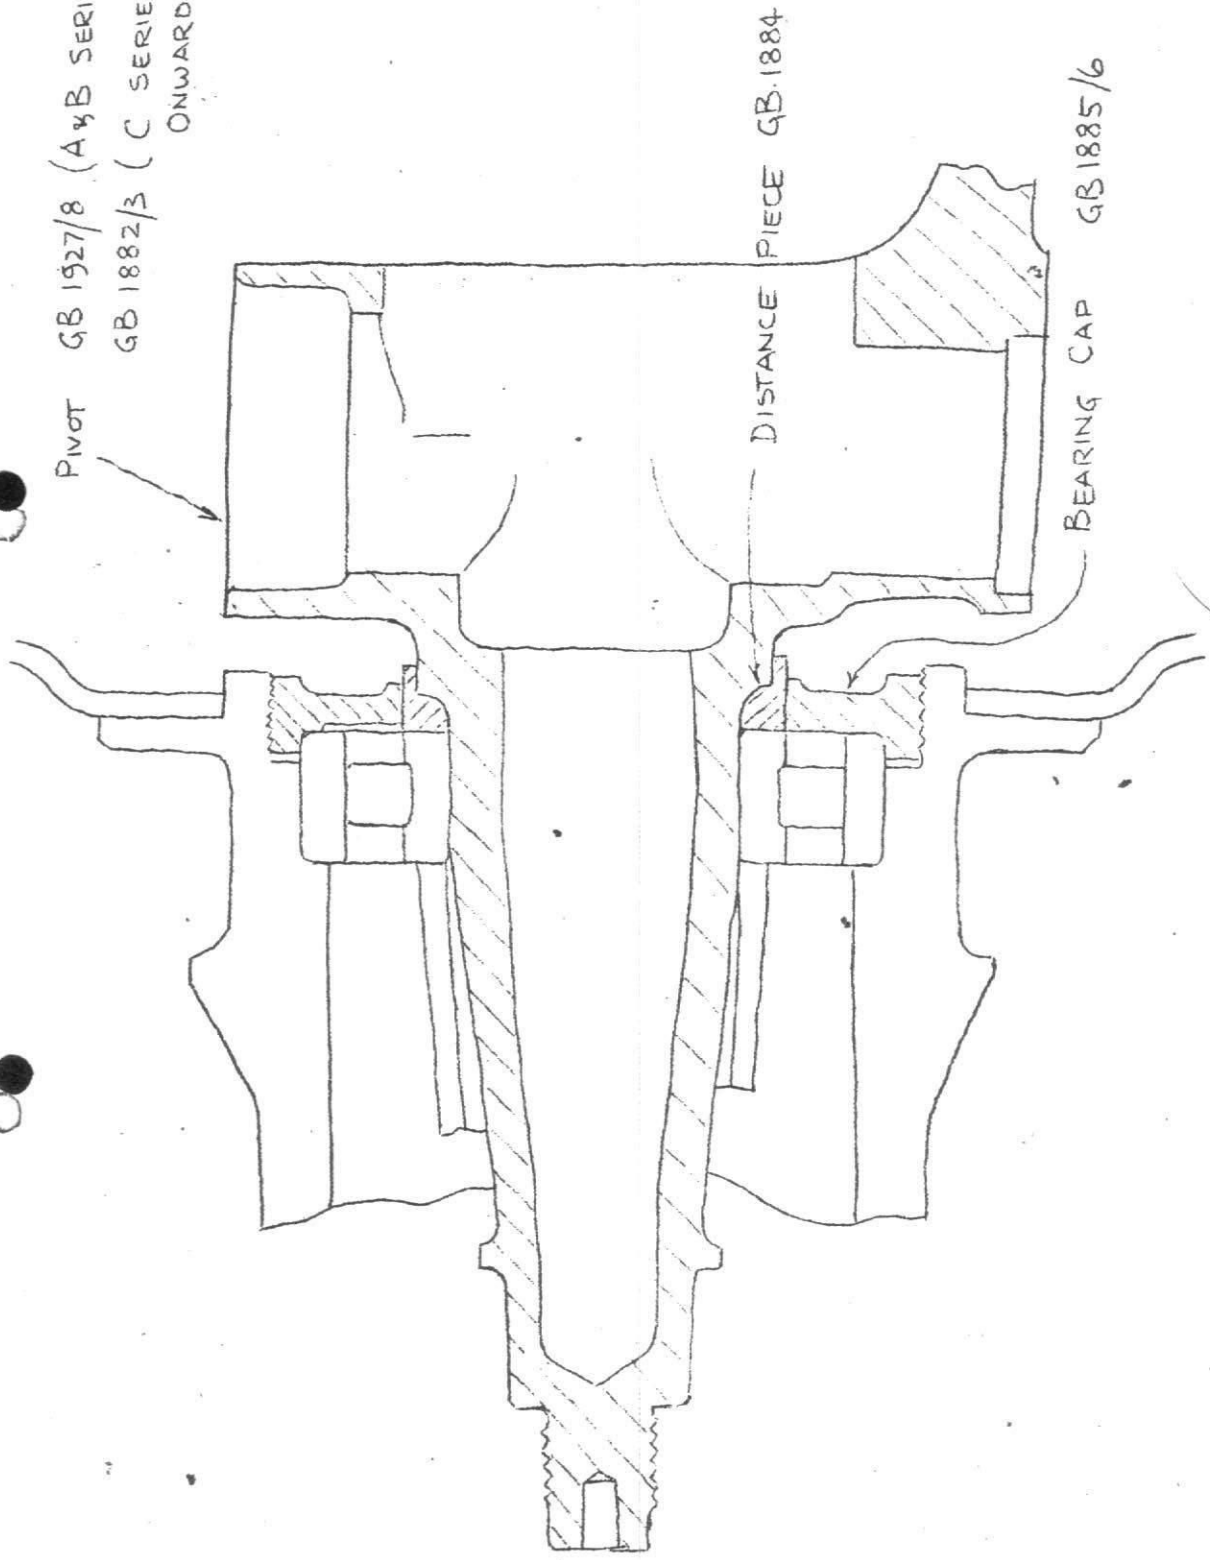
STRENGTHENED PIVOTS - BENTLEY

The new pivots have been strengthened by reducing the size of the bore in the stub axle and a larger radius is added to the root of the stub axle where it joins the vertical pivot.

This necessitates the fitting of a distance piece behind the inner ball bearing and the fitting of new ball race covers as shown in the sketch attached.

On A. and B. series chassis the new pivots required are GB.1927/8, whilst on C. series onwards, pivots GB.1882/3 are required.

With regard to the new bearing caps GB.1885/6, which are required, it should be noted that where facilities are available the existing caps may be modified by increasing the 1.9375" diameter bore to 2.046" diameter.

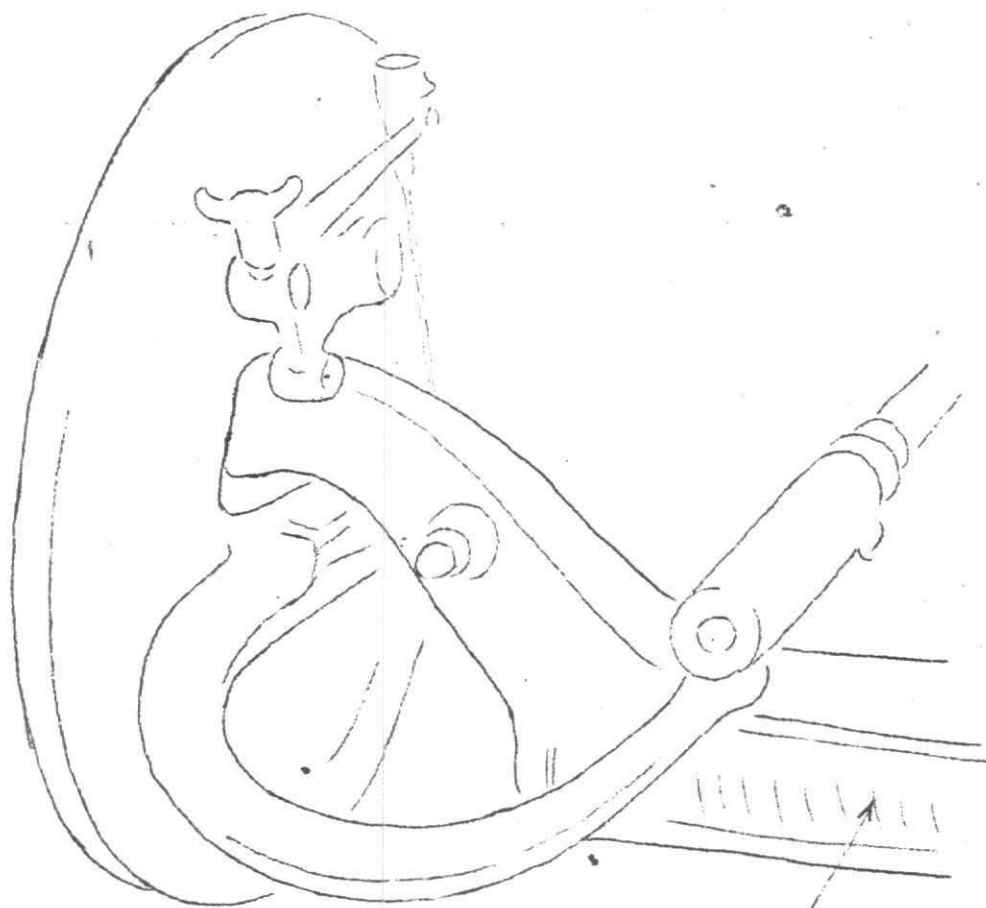
STAMP LETTER 'P' HERE

When the pivots have been changed, the letter "P" should be stamped on the offside brake actuating tunnel on the axle, as shown in the sketch.

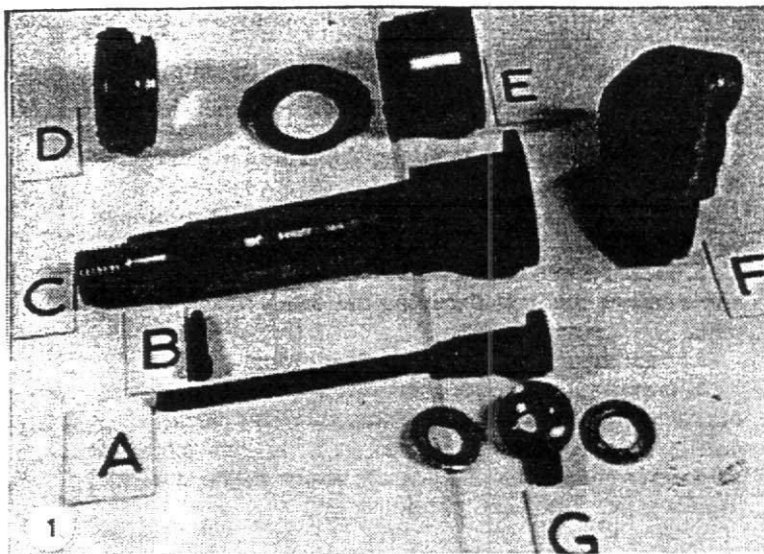
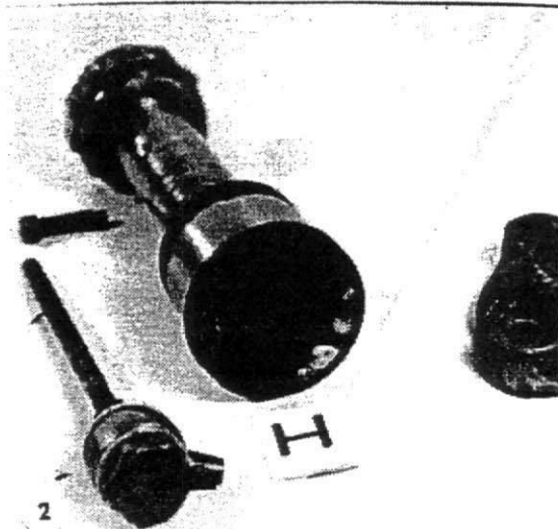
Parts shown are 1938 4 1/4 Bentley but sufficiently alike R-R for purposes of illustration. A knowledge of how the parts in photo 1 are assembled is needed for full understanding of the lubrication method.

**Rusted Bearing E:** The bright area on E may be misleading, this is not a working surface kept bright by rotation but a ground finish which has stayed clean since original installation. The thick base section of pin C gives a clear idea of the actual condition of working surfaces--badly worn, scored, and pitted with rust, with the interior of bearing E in the same condition.

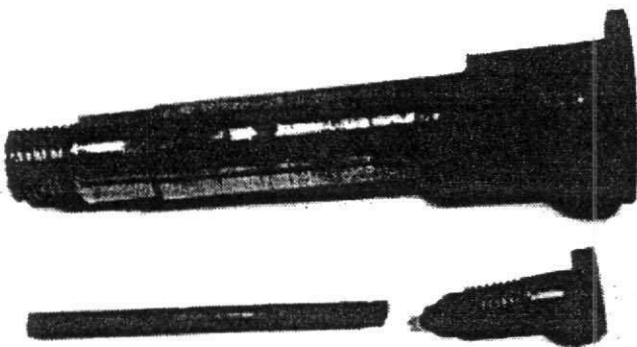
**Metered Flow Upwards:** In photo 3, J is a 5/16" aluminium washer with central hole about 3/32" dia pushed into the top of pin C to meter oil flowing upwards.

**Standpipe Fracture:** Another fairly well-known fact is that the standpipe can fracture, cause oil to flood internally and ruin the brake linings. Photo 3 at 1 shows a broken standpipe which has failed just inboard of the bottom flange F. "Necking" can be seen on standpipe A at the same place, and its failure was fairly imminent, due to rust and pitting. The rust condition of the standpipe, pin C, and interior of bearing E is assumed to come from grit laden water running down the backplate outer face, into the lower yoke, and running between pin C and bearing E where wear has developed, to collect in cavity H.

**Repairing Standpipes:** 3/16" dia Bundy hydraulic tubing is suitable for replacing the old piping. Fix in place with soft solder as before.

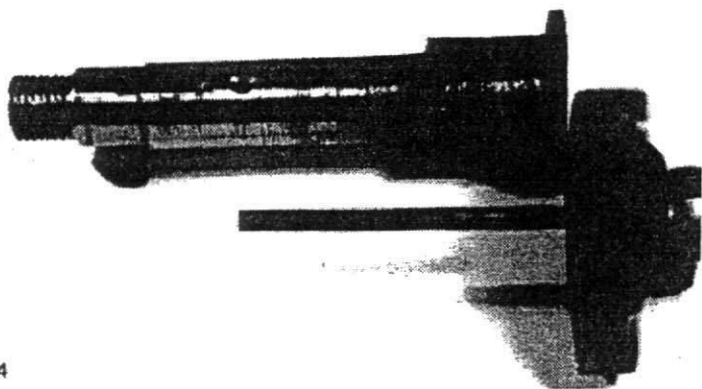
**Length of Standpipe:** Photo 4 shows that the standpipe, when in position, reaches a point inside pin C flush with the bottom edge of the oil hole.
