# SERVICE INSTRUCTION LEAFLET

BENTLEY MOTORS (1931) LTD.

Engine - Tappet Clearances  
3½ and 4¼ Litre Bentley.

22nd Nov. 1945.

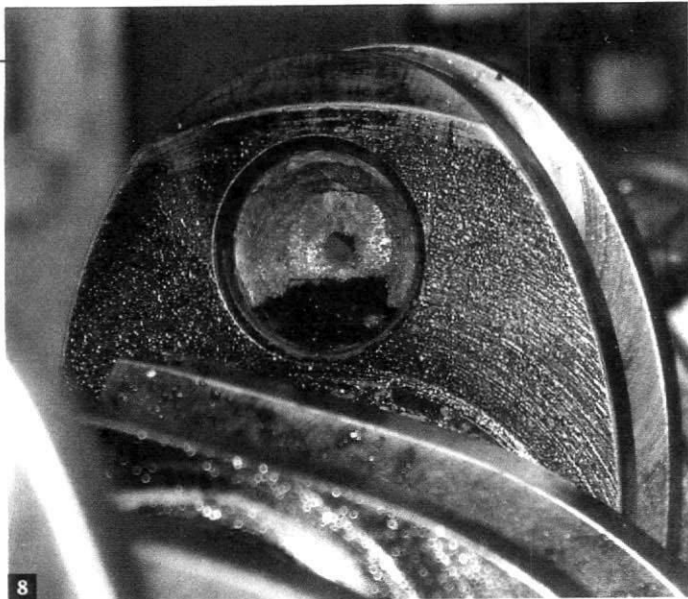
70% occluded crankshaft journal (courtesy Dennison-Jayne Motors).

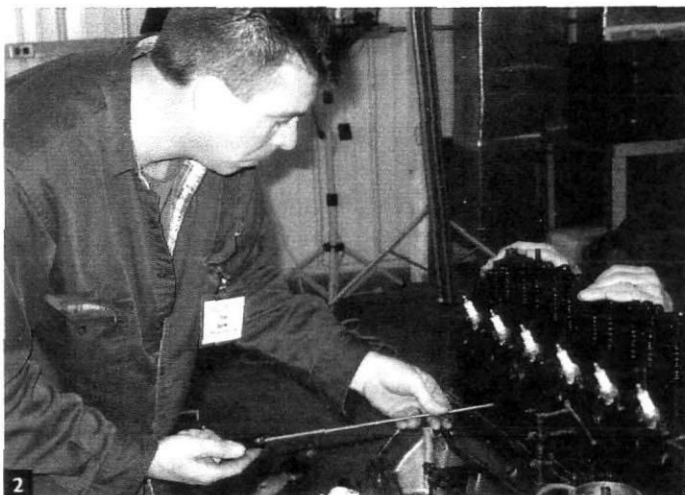
2 Tim Jayne uses a long screwdriver with tip ground to exactly fit the 2BA screws that hold on the side plates on the block.

to clean out accumulated silt and rust **1**, **2**. The copper tubes running through the block and head should be removed to gain increased access for cleaning **3**. New copper tubes with annealed ends should be installed and swaged into place after the block and head are thoroughly cleaned. Tim recommended having the block, head and radiator ultrasonically cleaned.

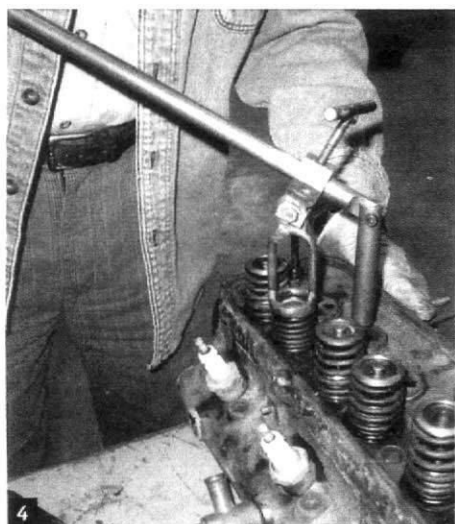
**4** Shop-made tool to compress valve springs. The end is threaded  $\frac{1}{16}$ " BSF and screws on to the rocker arm bolts. The handle has a sliding arm to center the tool over each valve spring. This design allows you to remove the two valve springs closest to each rocker arm bolt.

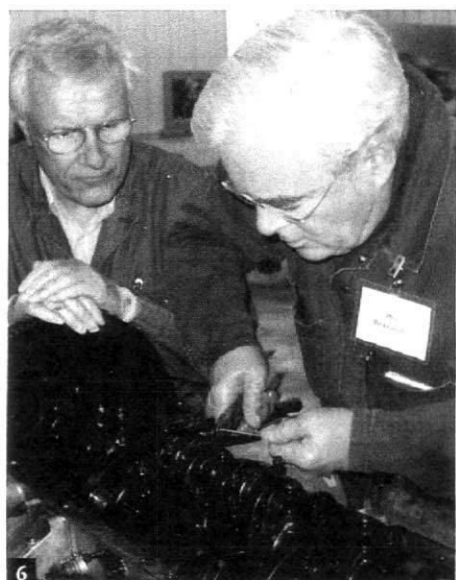
**6** Peter Sedmihradsky (ONT) and Phil Birkeland (WA) work on removing the numerous cotter pins securing the castellated nuts on bearing caps.

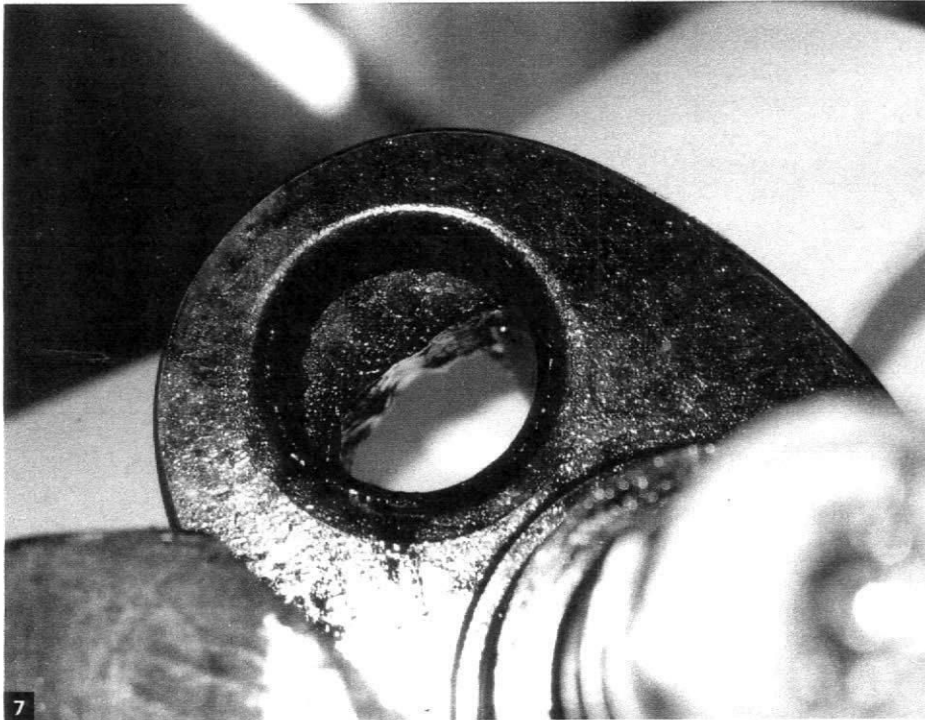
**7**  
The crankshaft has hollow journals that fill with oily sludge as a result of the centrifugal-like action of the spinning crankshaft. Aluminum plugs seal the ends of the journals and are held in place by through-bolts. The plugs should be removed and the sludge cleaned out so that oil flows freely to the big ends of the connecting rods. Note build-up of sludge in journal.

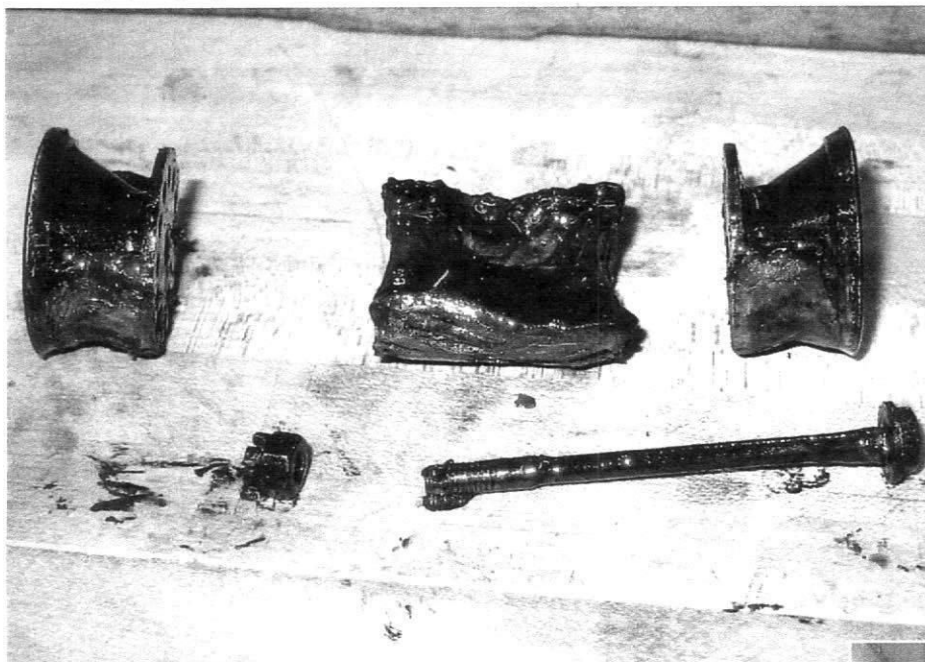
**8**  
Aluminum sludge trap seals showing build-up of oil sludge and plug of sludge (middle) removed from journal.

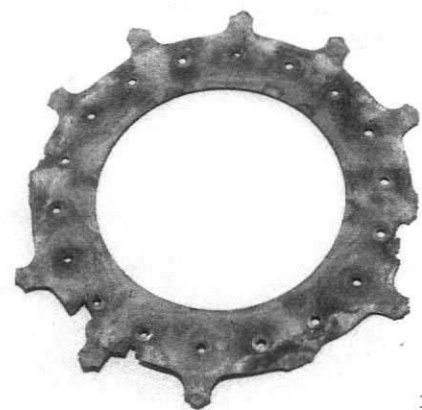
1

Oil from the engine high-pressure circuit, after passing the damper bearings, enters the body of the damper to provide lubrication for the friction plates. Unfortunately, with the engine running, there is no path for the oil to leave the damper. Therefore the damper case becomes a large and very effective sludge trap.

The centrifugal forces, present there whenever the engine is running, soon begin to deposit carbon and sludge, brought in along with the oil, until the damper is filled rock solid with the exact same deposits which fill the crankshaft sludge traps. As this action is progressing, water (principally from condensation) also finds its way into the damper body where it too is trapped, and quickly goes to work rusting through the very thin fingers of the spring plate. After these fingers are sufficiently weakened they will shear under the friction pull on the plates (see **Photo 1** for an example). Now, with the spring plate out of service, the radial load will transfer to the compression springs which will quickly break up under the side loading. At this point, the slipper drive is totally ineffective and the crankshaft torsional vibrations are no longer being dampened. If you listen to the gear case of your engine at idle with a stethoscope at this stage, you could easily hear the rattling noise of broken spring bits inside the damper case. But an even worse condition than this is also common.
