**Springs & Shock Dampers**

# SERVICE INSTRUCTION LEAFLET

SHOCK ABSORBERS  
ALL PRE-WAR CARS WITH RIDE CONTROL.

## Renewing Semi-Elliptic Springs

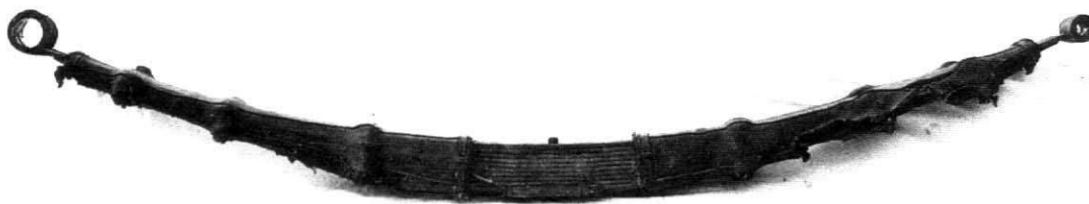
**Figure 1:** Rear semi-elliptic spring from Phantom III, 3BU86, still gaitered, and prior to disassembly.

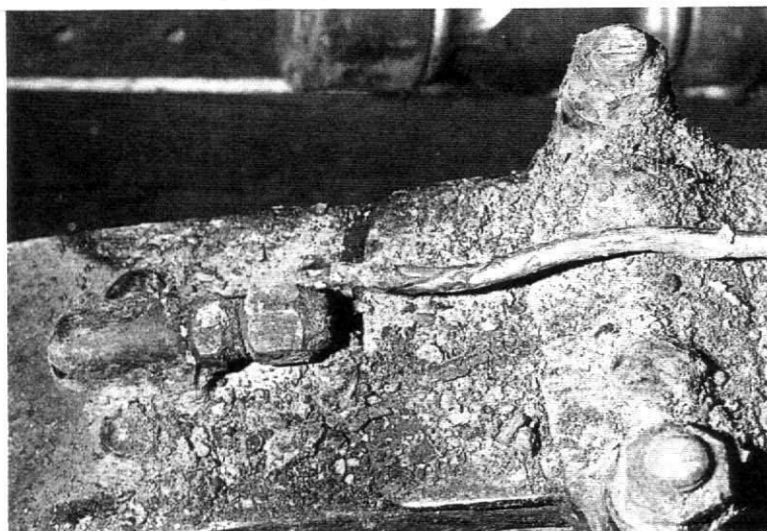
**Figure 2:** Even under the gaiter, you may find dirt or a broken Bijur line. No wonder these springs required overhaul.

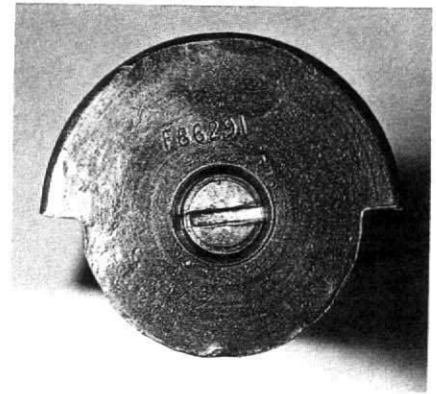
**Figure 3:** Typical shackle pin that has not been receiving adequate lubrication. Note the worn areas where the bushings were, and the slightly damaged thread where the pin was driven out (with the nut on, please!). The center oil hole was so blocked that it had to be drilled out. **Figure 4:** End of shackle pin after cleaning and removing the solder that sealed the screw. A well-fitting screwdriver and heat, used together, are needed to remove it.

evident. The shaft portion of the pin should be the same diameter along its entire length. If ridges are present, the proper diameter *must* be restored, either by replacing the pin or by building the pin back to correct size. Since the spring receives its lubrication from the Bijur system, proper fit of the pin in the bush is essential for adequate lubrication of the spring.

The shackle pin has a blind channel drilled into one end. Oil passages are drilled to connect with this inner channel. The blind channel is sealed from the head end of the pin with a screw which has been soldered in place. If you plan to re-use the old shackle pins, direct a torch at the head of the screw to melt the solder and give access to the screw head. Heat the screw head again and remove it from the pin. Clean the interior of the pin and open all of the oil passageways. If the pin is to be re-used as is, replace the screw and re-solder. If the pin needs to be built up, leave the screw out for now, replacing it after the pin has been repaired.

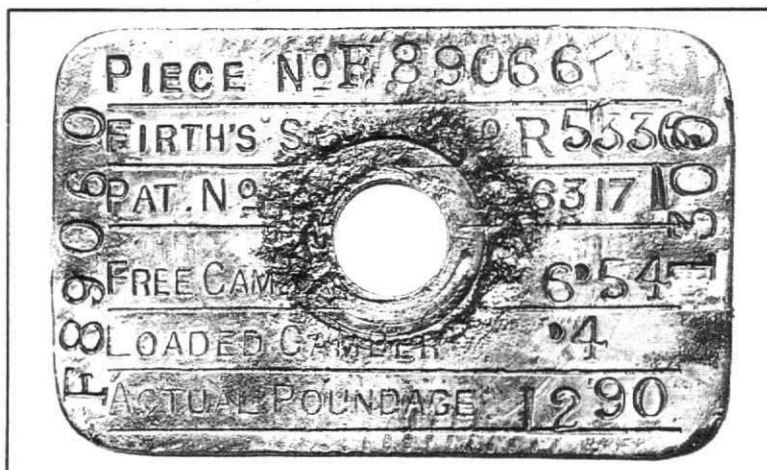
**Figure 10:** The documentary record: the construction and test card for 3BU86's springing. **Figure 11:** The archaeological record: the metal spring plate for the left rear spring, as excavated from the rubber block at the center of the spring.
