Fuel & Carburetion

# SERVICE INSTRUCTION LEAFLET

Subject : HUBS, REMOVAL, FRONT AND REAR.  
3½ AND 4¼ LITRE.

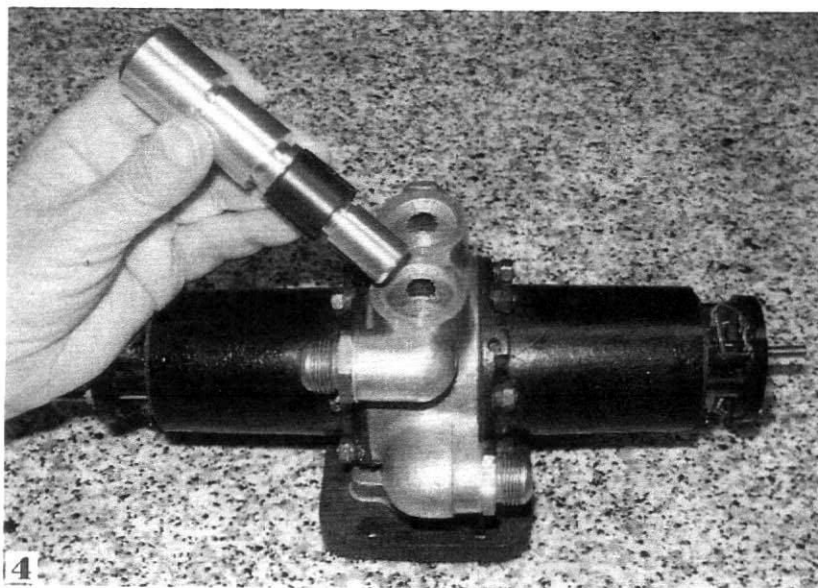
**4** Valve seat lapping tool generated from a left over project from lathe school.

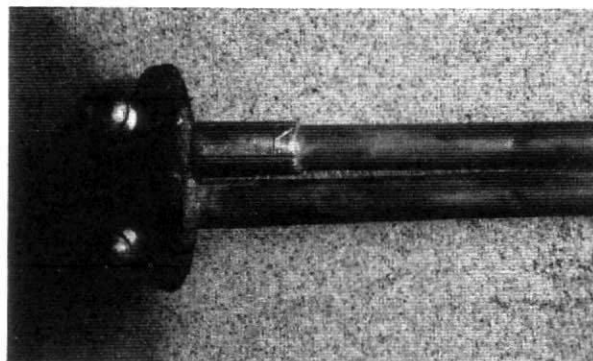
Sleeve in place after application of epoxy.
