FITTING OF RADIO SETS TO R.R. AND BENTLEY CARS.

MODIFICATION TO WILMOT BREEDON BUMPER

## COACHWORK REPAIRS

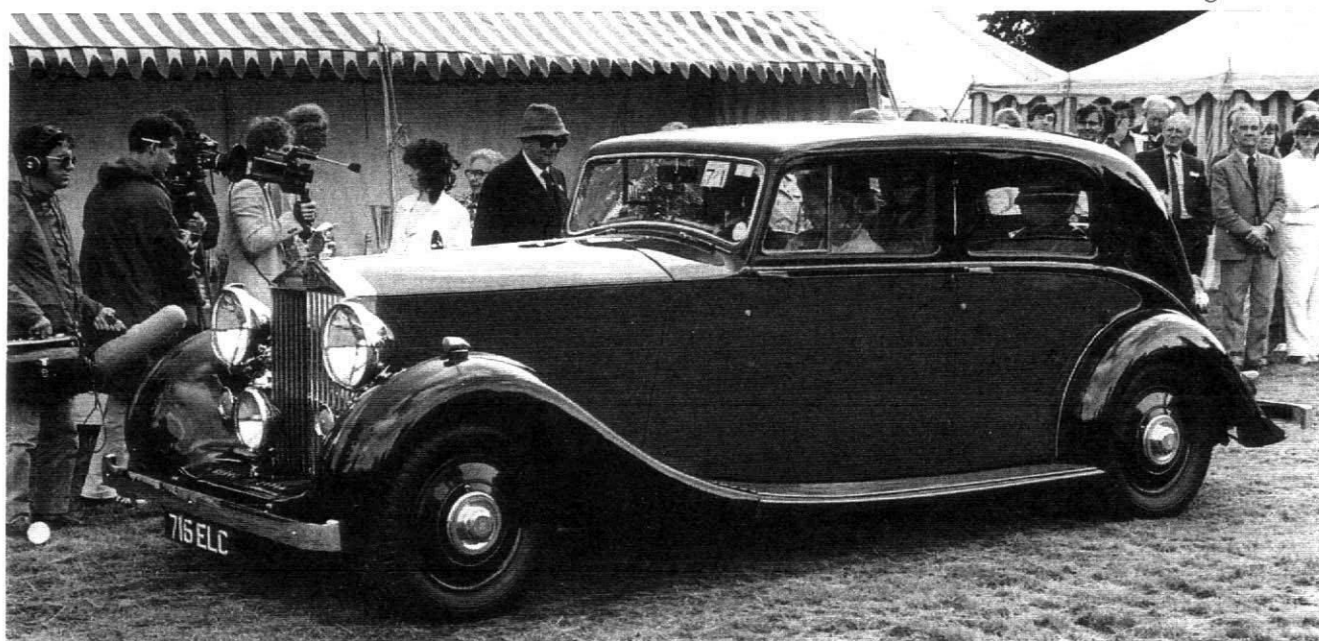
WRB34, 1934 Wraith Park Ward saloon, showing lining splitting at the scuttle to follow the top and bottom moulding edges.
